THEME CONDENSER CORROSION

CONDENSER CORROSION - POSSIBLE ISSUES

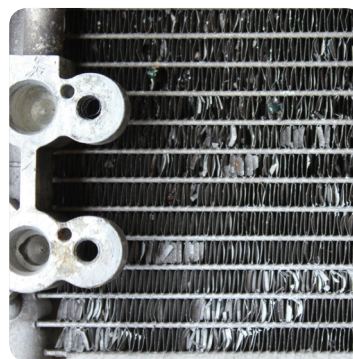
Deterioration of condenser fins – Even if the condenser does not leak and seems to be tight, the heat exchange capacity can have been reduced significantly. As corrosion attach to the thin aluminum fins, the working surface area is reduced, which will reduce the overall heat exchange capacity of the condenser.

Visibly deteriorated condenser fins

Especially, pay attention to the condenser bottom part, where tubes and fins are mostly exposed to extensive humidity and aggressive salt spraying. Oil residues on the condenser indicate leaks. Always replace a condenser that is leaking or has missing/deteriorated fins.

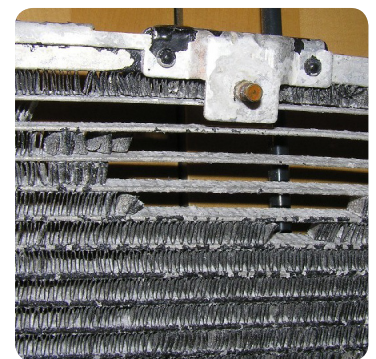
Lack of fins – As the fins corrode over time, they will fall out of the condenser. With the number of fins reduced, the condensation process will become significantly more ineffective, creating an increased overload on the compressor. **Removal of only one fin row from the condenser can reduce its thermal performance by up to 3%!**

Several rows of missing fins caused by condenser corrosion

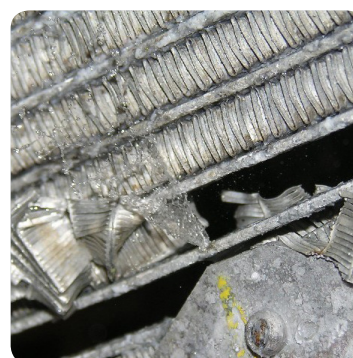
Leaking condenser – Testing has shown that a condenser with missing fins, due to corrosion caused by saltwater, will eventually start to leak. The leakage is caused as the lack of fins destabilizes the condenser construction, making it more vulnerable to wear and tear. As the refrigerant disappears, the system will not function properly. Furthermore, as the lubricant cannot be distributed in an empty running system, the compressor will be exposed to overheat and seizure.

Leakage caused by missing fins

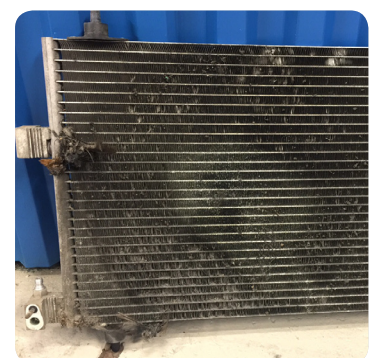
Seems tight, however, a condenser in such a condition cannot perform well and must definitely be replaced

When replacing condensers, choose parts with corrosion protection applied. This prolongs its lifespan considerably. Advanced saltwater tests have shown that condensers that are treated with corrosion protection can function up to eight times longer than a non-protected condenser. Nissens applies special protection to +500 condenser models particularly exposed to corrosion.
