THEME CONDENSER

CONDENSER INNER CLOG

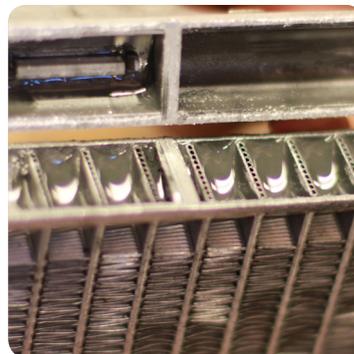
Black, carbonized oil will quickly clog the condenser's inner tubes

No/poor flushing – A thorough system flush must always be performed prior to a new component installation - especially after a compressor seizure. When a compressor has seized, metal chips can break off and cause clogging in the system. Furthermore, carbonized oil particles, developed due to compressor overheating, can cause clogging in the system and must be flushed.

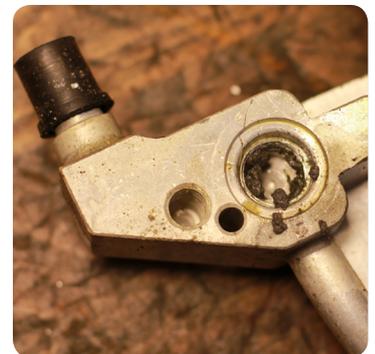
Visible soiling at the condenser inlet

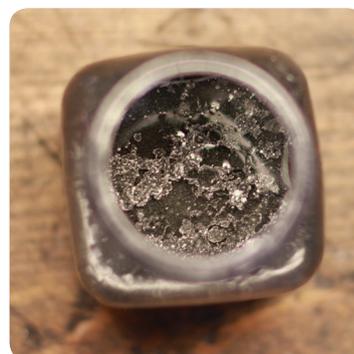
Oil drained from a seized compressor. The visible contaminations are spread in the entire system, including the condenser.

Furthermore, it is always required to perform a system flush after a compressor breakdown. Make sure that no flushing agent residues remain in the system after flushing.

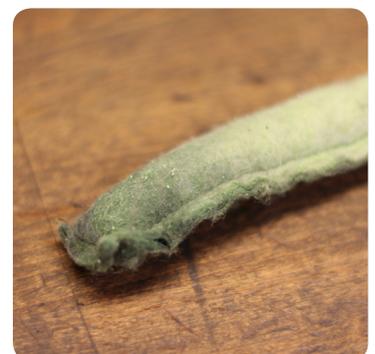
Worn out receiver dryer (or desiccant bag cartridge) often results in clogging of the condenser's inner tube

To keep the condenser in good condition, the receiver dryer must always be replaced during a compressor replacement, if the circuit has been exposed to ambient air, or the system has run empty, due to leakages. If none of these events occur, it is recommended to replace the receiver dryer every second year.

Receiver dryer in bad shape – Poor condition of the receiver dryer means that it will become less efficient in filtering particles, increasing the risk of impurities flowing through the system. This will eventually lead to clogging of the condenser and other components.
